PHOTOGRAPHIC INTERPRETATION REPORT

JULY 1965  
COPY 4  
8 PAGES

## REVETMENT MEASUREMENTS, SELECTED SAM INSTALLATIONS, USSR

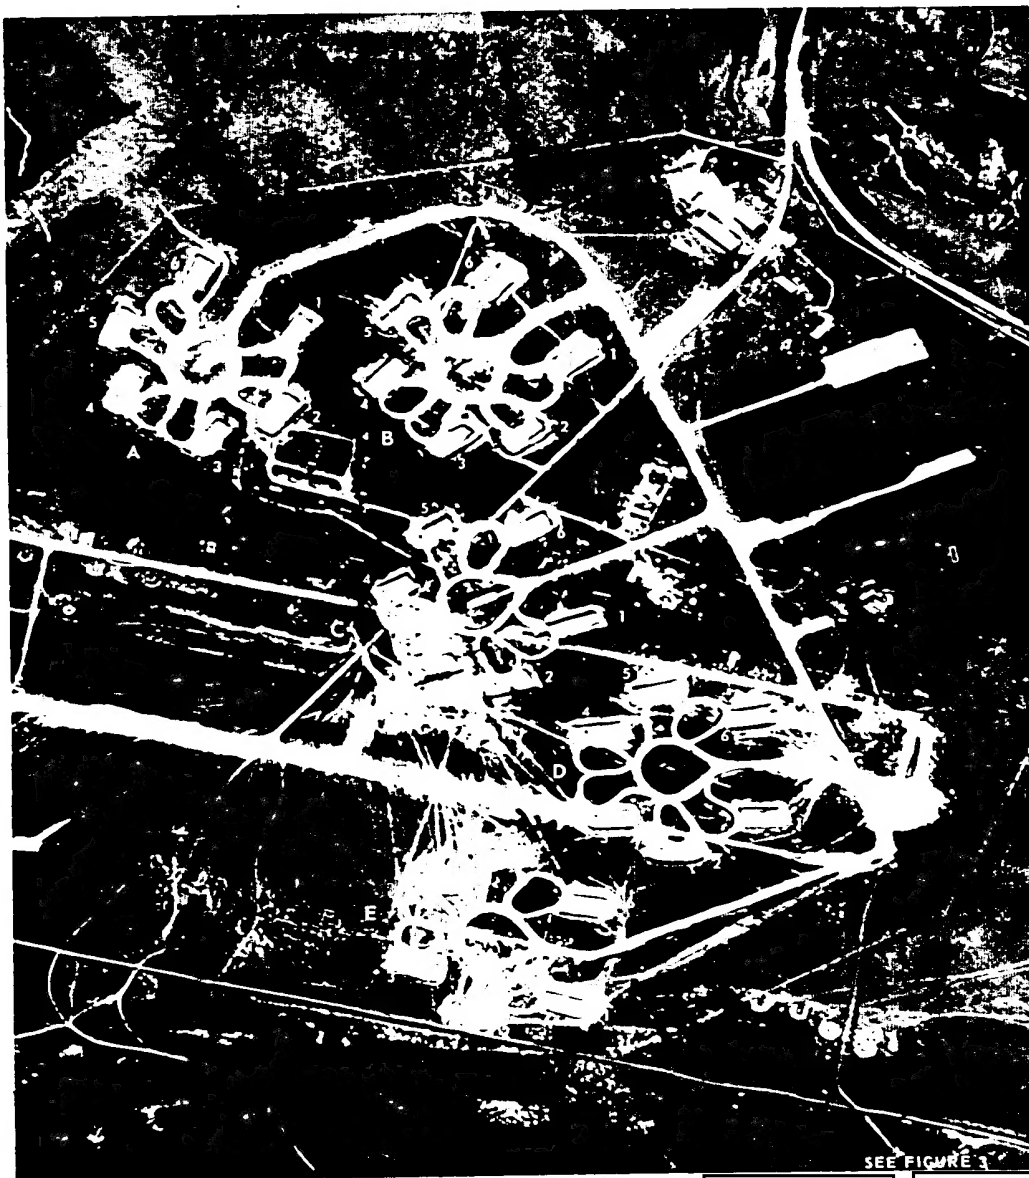
FIGURE 4. TALLINN AMM SAM LAUNCH COMPLEX

Because of the varying construction stages of launch positions at the Tallinn complex as it appears on photography used for this report, discrepancies are apparent in the widths of the revetments (Figures 3 and 4). To facilitate an understanding of the differences, a table (Table 1) showing the status of each position (as observed on [redacted])
